Manhole Inspection Summary

Manhole # S27S__002MH

Insp Date: **4/24/08 2:22 PM**

Location Address: **1800 front side of lot Bayard st**

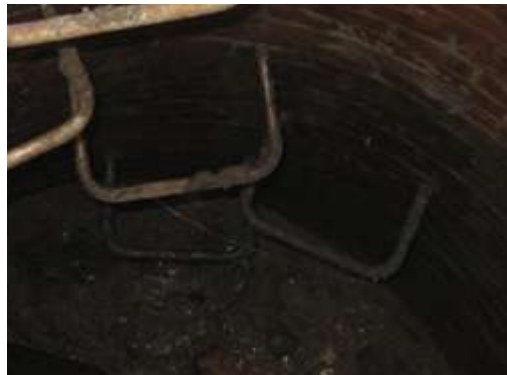
Defect 5

☒ **Evidence Of Surcharge** Depth: **4** (ft.) ☐ Active Surcharge Present

signs of surcharge on steps

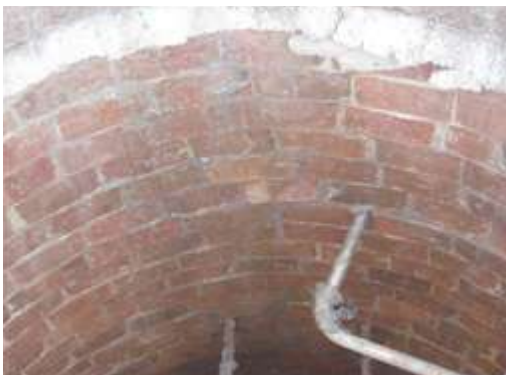
Defect 4

Infiltration: ☐ None ☐ Joint ☐ Cracks ☐ Mortar ☐ Roots ☒ **Wall**

signs of infiltration corbel

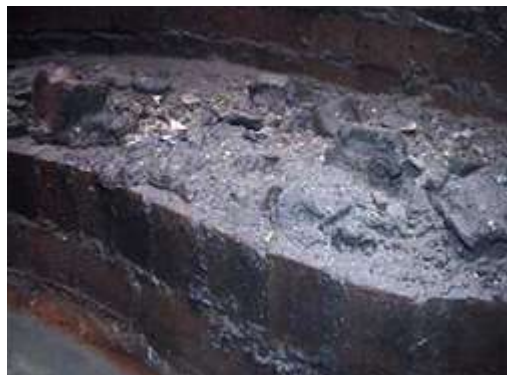
Defect 3

Condition: ☐ Sound ☐ Cracked ☐ Root Intrusion ☐ Deteriorated ☐ Leaks ☒ **Debris**

debris on bench

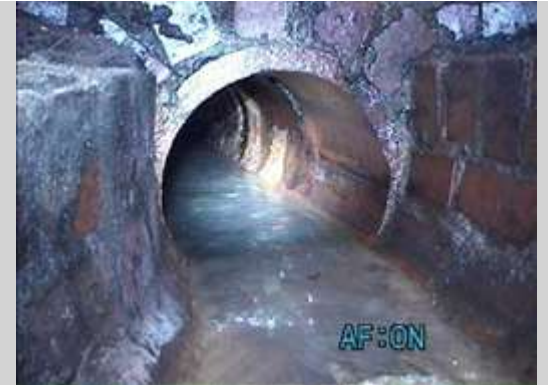
12 O'Clock Outflow

10 in. Circular Gravity Sewer
Pipe Out @ 12 O'Clock

Pipe Height: **10.8** (in.) Rod and Bar (Angled)
Pipe Material: **Clay** ☐ Pipe Lined
Invert Depth: **13.24** (ft.) Flow Characteristics: **Fast**
Deposits: ☒ None ☐ Mud ☐ Sludge ☐ Debris ☐ Grease
Silt Depth: **0** (in.) Deposits Extent:
Infiltration: **None** Pipe Seal Cond: **Sound**

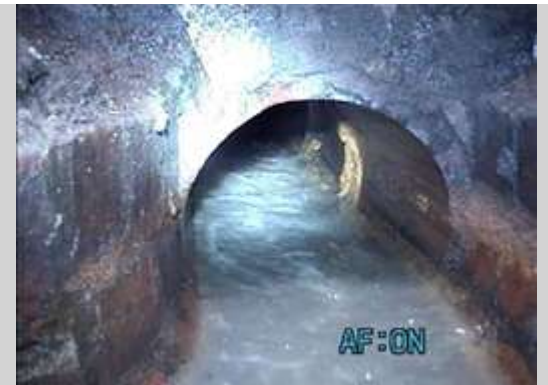
6 O'Clock Inflow

10 in. Circular Gravity Sewer
Pipe In @ 6 O'Clock

Pipe Height: **10.8** (in.) Rod and Bar (Angled)
Pipe Material: **Clay** ☐ Pipe Lined
Invert Depth: **13.30** (ft.) Flow Characteristics: **Fast**
Deposits: ☒ None ☐ Mud ☐ Sludge ☐ Debris ☐ Grease
Silt Depth: **0** (in.) Deposits Extent:
Infiltration: **Evidence** Pipe Seal Cond: **Unknown**
